Resolution Accepting the Finding of Necessity Study for the Goulds/Cutler Ridge Area

Finding of Necessity Study Goulds Proposed CRA

Prepared for Miami-Dade County
by
The Curtis & Kimball Company
In association with
Mark Alvarez
Cathy Sweetapple & Associates
Miami Economic Associates

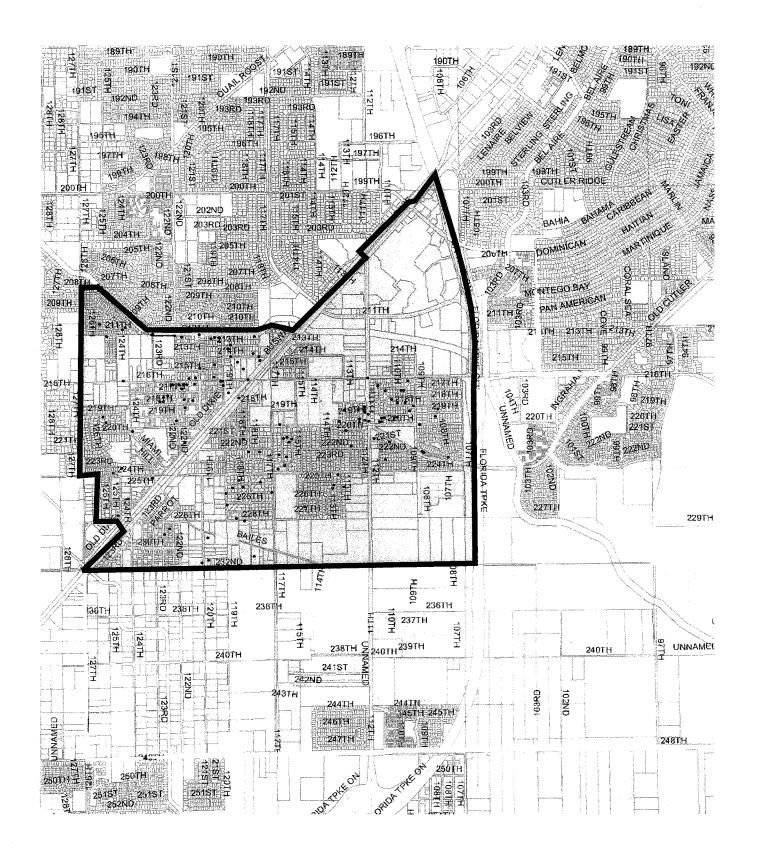
Figure 5 Open Code Violation Map Goulds / Cutler Ridge CRA

To further support the visual survey, data was gathered from Miami-Dade County with respect to code violations. **Table 4, Open Code Violations**, lists the open code violation cases and **Figure 5, Open Code Violations** shows the extent of the code violations throughout the study area. Details of the open code violations are contained in **Appendix A**.

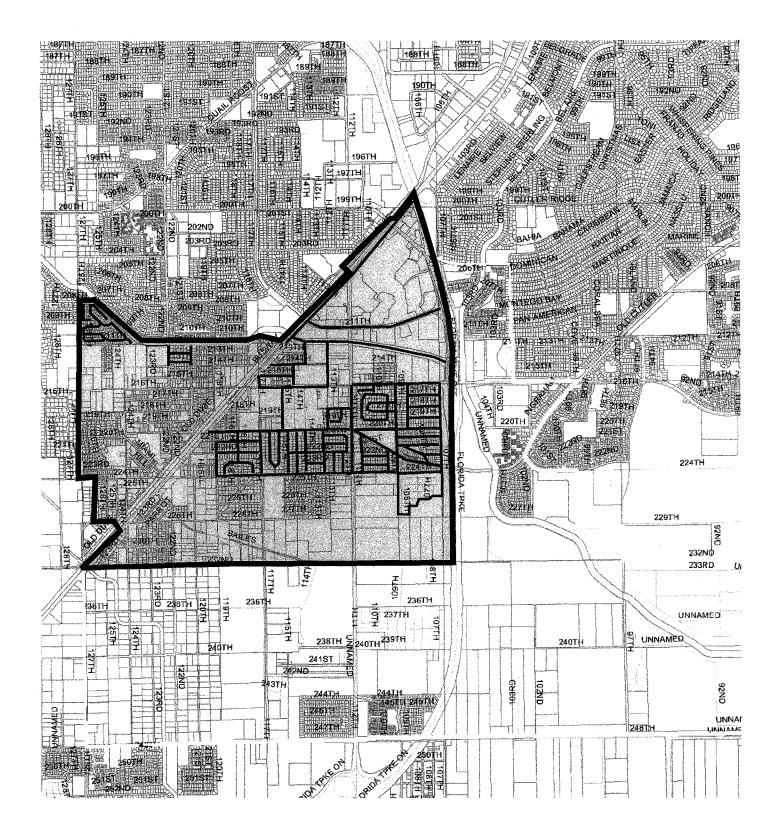
Figure 13 Sidewalk Locations Goulds / Cutler Ridge CRA

The older and unimproved sections of the CRA study area have been found to exist with incomplete pedestrian infrastructure (see Figure 13), which impacts the provision of services and facilities used to support public transportation. Approximately 78% of the study area has no pedestrian infrastructure, while over 60% of the land area located within the CRA boundaries is located within one mile of the Busway corridor. The remaining land area is located within one mile of Bus Route 70, traveling north and south along SW 112 Avenue (see Figure 14). Three Miami-Dade County transit routes (plus the busway) operate along US-1 and serve the Southland employment center in the northern end of the CRA study area. A fourth transit route also serves the employment center, but provides access to the Cities of Homestead and Florida City using the SW 112 Avenue corridor. Service frequency headways throughout the CRA study area range from 15 minutes to 30 minutes. Considering that the entire CRA study area is located within a mile from a transit corridor, and given the extension of the busway which is currently under construction adjacent to the CRA along US-1, an extensive and continuous network of pedestrian facilities should exist to reinforce connectivity with the transit service along US-1. The existence of intermittent sidewalks within the CRA boundaries contributes to the inadequacies of the street layout and the deficiencies which exist in the provision of pedestrian infrastructure.

Sidewalks on both sides of street Sidewalks on one side of street Property boundary

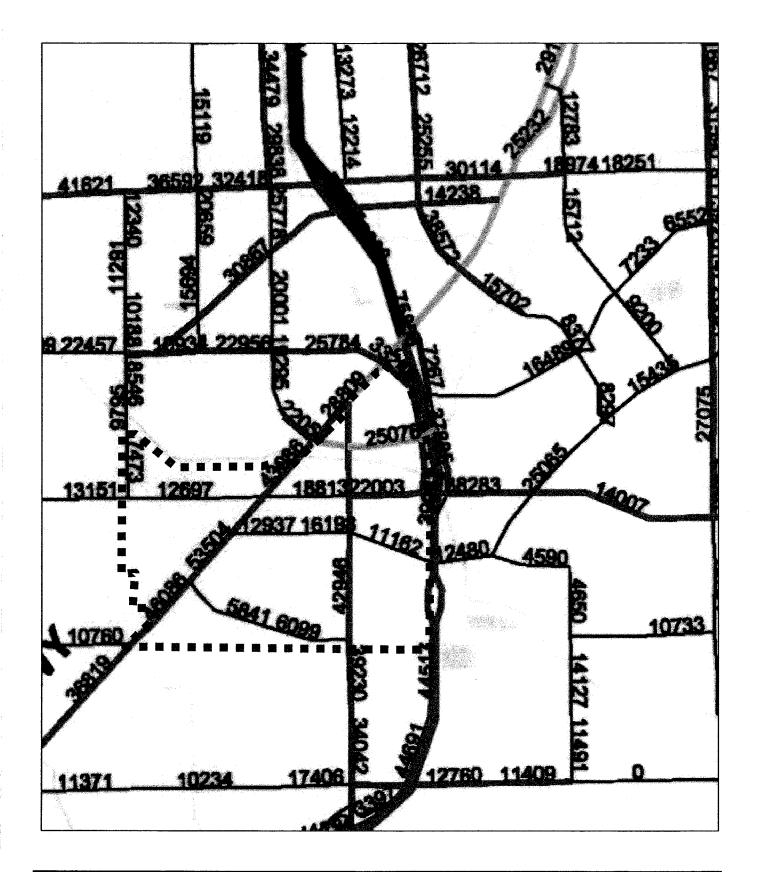
Figure 15 Year 2025 Traffic Forecasts Goulds CRA

Daily traffic data has been obtained from FDOT and Miami-Dade County for the count stations located adjacent to and within the CRA study area. Traffic forecasts for the Year 2025 were obtained from the Year 2025 traffic projections from the Long Range Transportation Plan (see **Figure 15**). Planned roadway improvements for study area roadways (from the LRTP 2030), are outlined in **Table 14** below, and are included in **Figure 16**.

XXXXX Year 2025 Projected Traffic Volumes
